Watch Out for Dents on Liquid Filters!

Shoptalk

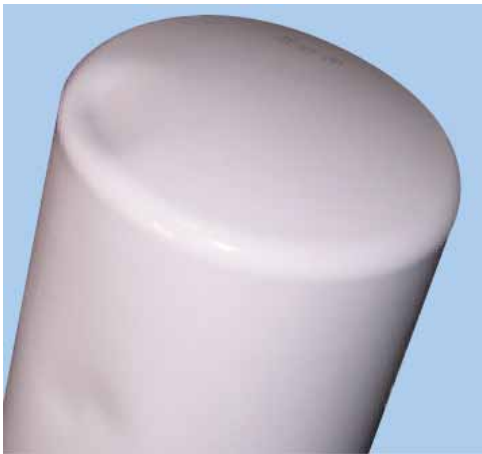
Dents in a steel filter canister create a concentration of stress, making the canister more susceptible to fatigue.

Cracked filters can be caused by dents made during improper installation of liquid filters. Filters that are dented prior to or during installation should not be used. Filters dented after installation should be replaced immediately. The cost of replacing a dented filter is much less than the cost of the damages that could result from a dented filter that fails during service.

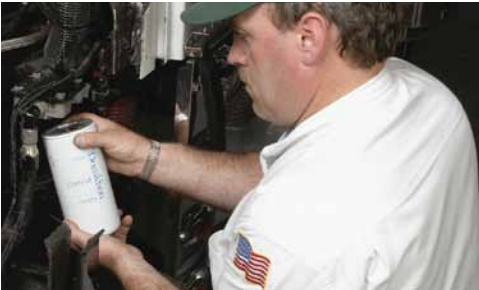
Filter fatigue results from the pressure pulses within a system. Pressure is regulated by a pressure regulating valve. This valve is spring operated and intermittently opens and closes to regulate the pressure. Once the pressure exceeds the setting of the spring in the regulating valve, the valve will open and relieve pressure until the spring can expand and close the valve. This function is repeated continuously during the operation of the system, creating a pulsing effect. The filter canister is subjected to the same pulsation. However, unlike the spring in the pressure regulating valve, the canister material is susceptible to failure after such fatigue.

Filters are designed with a low carbon steel to resist fatigue and are formed so the stress created by the pulses in the system are equalized over the surface area of the canister. A dent provides an area of stress concentration where pressure pulses can greatly shorten the fatigue life of a canister.
